**DESIGN REVIEW BOARD
AGENDA
Wednesday, November 9, 2016, 6:30 p.m.
Council Chambers, 209 S. Main Street, 2nd Floor**

1. Certificate of Appropriateness in the Historic Design Review District: An application for new signage at 411 W 5th Street (Dave's Pharmacy) in the BR (Business Residential) zoning district.

3. Certificate of Appropriateness in the Historic Design Review District: An application for exterior building modifications to the existing brick on the rear elevation at 119 N Main Street in the B-3 (Central Business) zoning district.

4. Certificate of Appropriateness in the Historic Design Review District: An application to remodel an existing rear deck and bring it into ADA compliance at 315 W 5th Street in the O-R (Office Residential) zoning district.

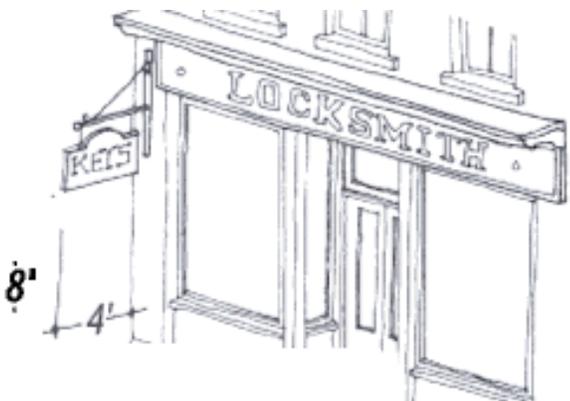
Storefront signs should be low enough for good visibility yet not interfere with pedestrian movement.

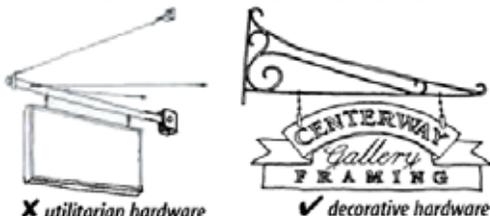
Although attachment hardware for signs need not be elaborate, it should be neat in appearance.

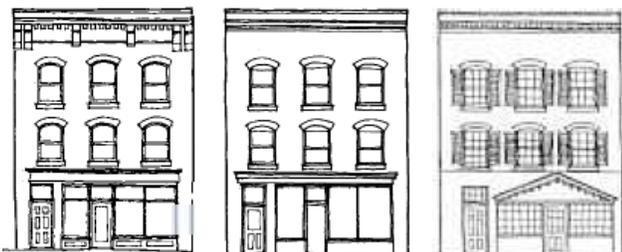
- ✓ **Reconstruct original**
- ✓ **Compatible new design**
- ✗ **False historic appearance**

Alternatives Treatments: When a building facade is severely damaged; appropriate alternatives include reconstructing its historic appearance, or designing a compatible new facade. Giving the facade a false historic appearance of an earlier period, however, is not appropriate.

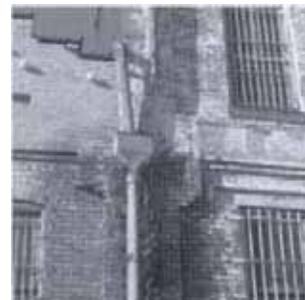
Repair damaged gutters that give rise to algae growth and washed-out mortar joints prior to cleaning and repointing masonry.

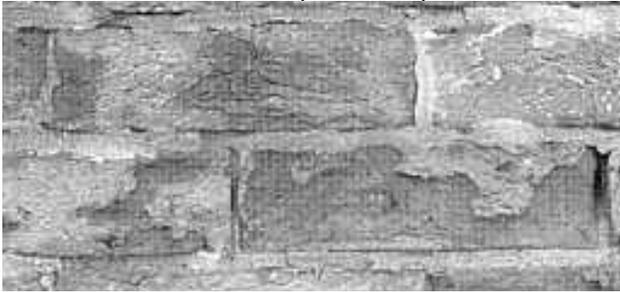
Sandblasting removes the outer-surface of brickwork, exposing the soft-interior to water penetration and subsequent freeze-thaw damage.

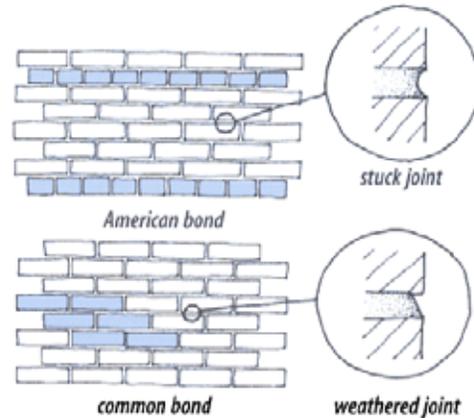
Typical brick bonds and mortar joints are used on Historic Uptown commercial buildings.

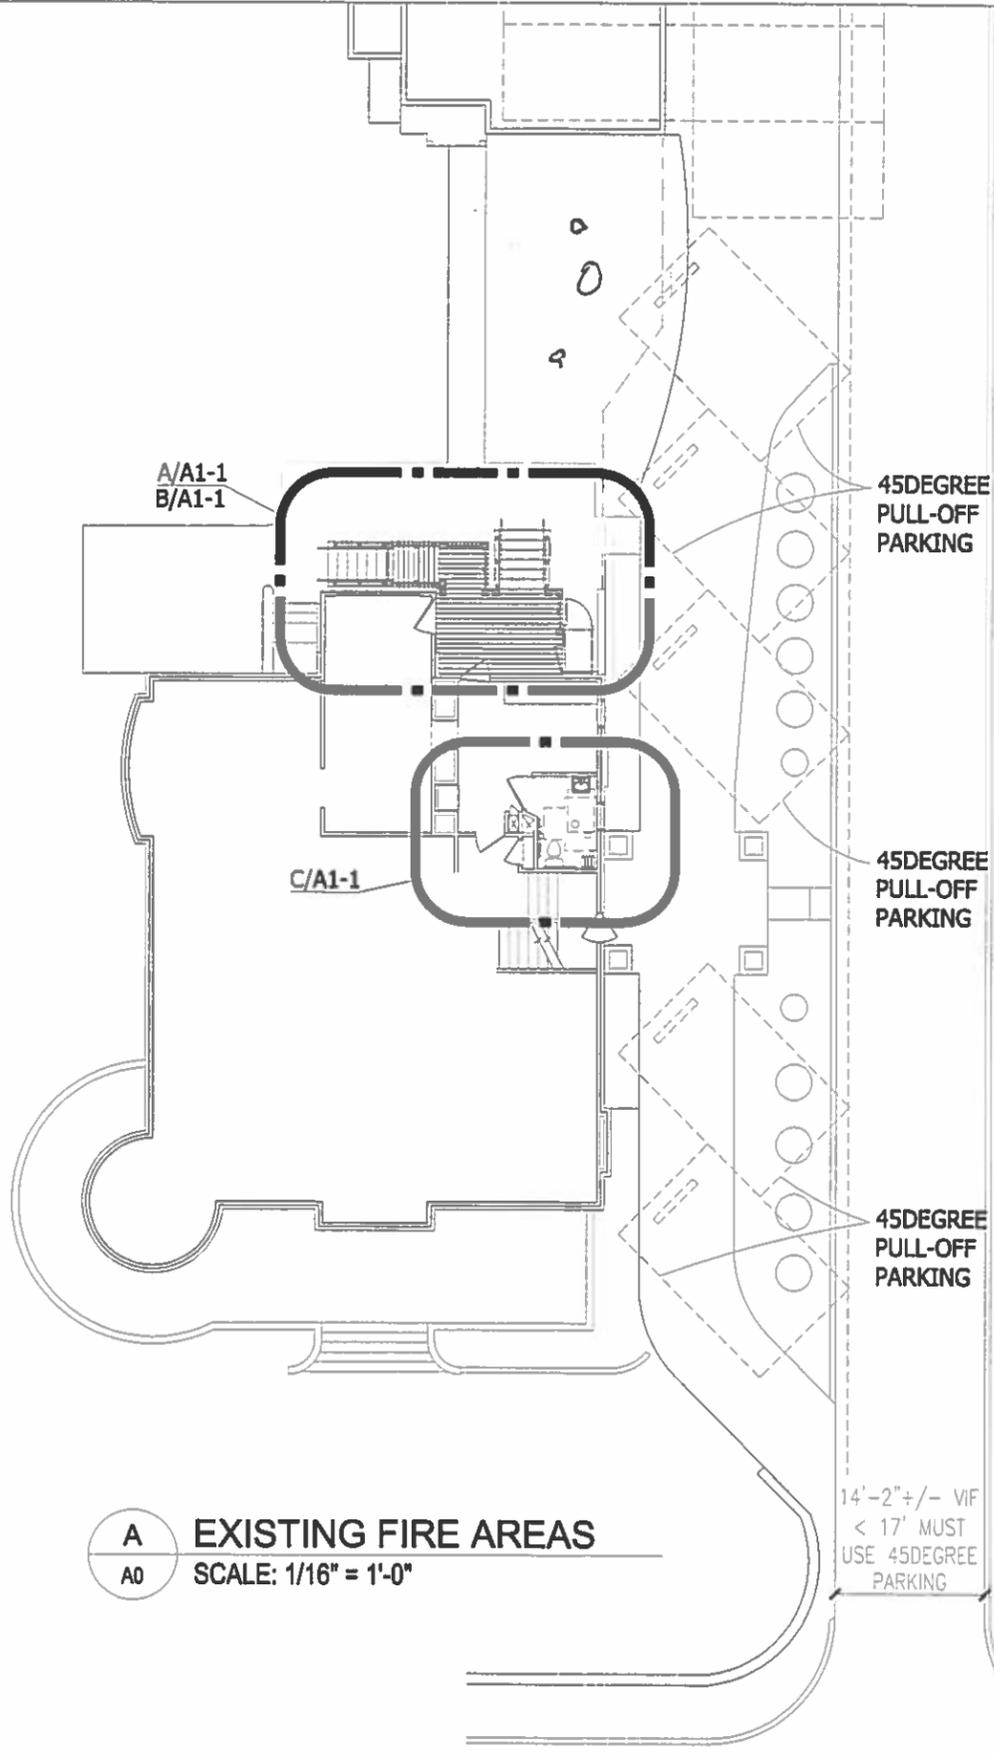
A
A0
EXISTING FIRE AREAS
SCALE: 1/16" = 1'-0"

B
A0
DEMOLITION
SCALE: 3/16" = 1'-0"

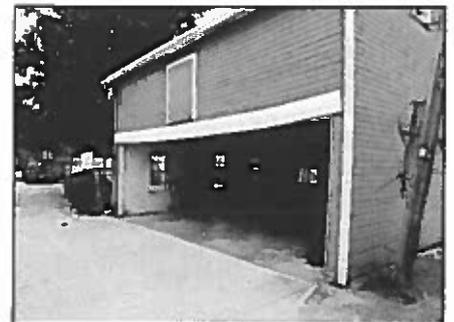
It is clear the structure is more contemporary than the primary building on site. The detached garage is of common gable end shape, two story in height (although not usable due to degradation and non-use), and clad in wood trim and horizontal wood clapboard siding.

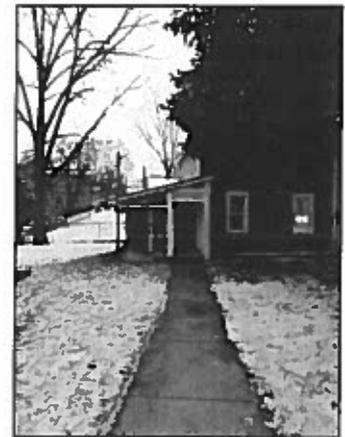
The east portion of the structure is a small storage space with mono-slope shed roof design. Although reminiscent of a salt-box shape, this structure is simply an effective shape and design for a typical outbuilding as is common today, as was in the early 1940-50's. We have no data as to show how old the structure is, however the steel used appears to be rolled steel which an engineer might be able to date as to production type.

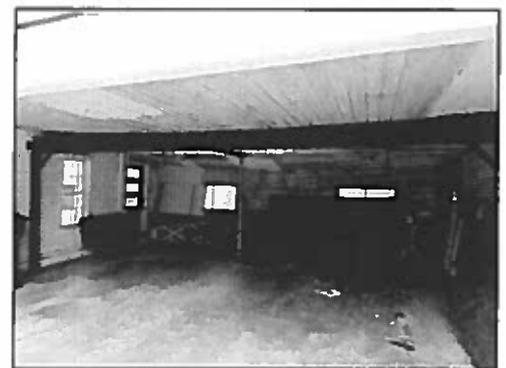
The detached garage is left open and often unused. It is unused as the patrons of the MGBC Mission feel uncomfortable and unsafe when inside the structure. We have not evaluated the structure with a structural engineer, but it is clear that the primary steel beam system carrying the framed loads from above have deflected the beam, which is apparent visually. The posts are also in a state of degradation.

The entire displacement of area for the garage and storage is approximately 700gsf.

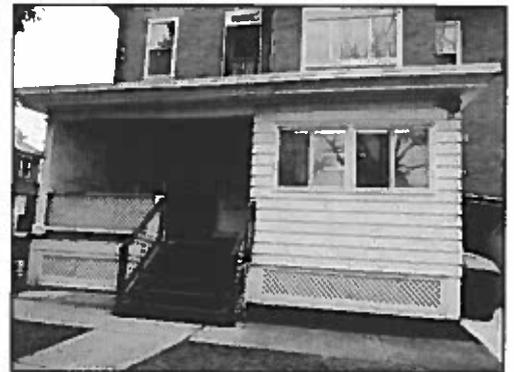
The rear deck area is access using a single set of wood frame stairs, and provides access from the rear set of doors out of the building. It appears to be of wood frame construction, and is tripped out and sided in clad wood materials. Of detriment to the true aesthetic of the primary structure is the use of lattice infill panels at the porch railing areas. This is not in character of the building, but probably added at a later time for privacy.

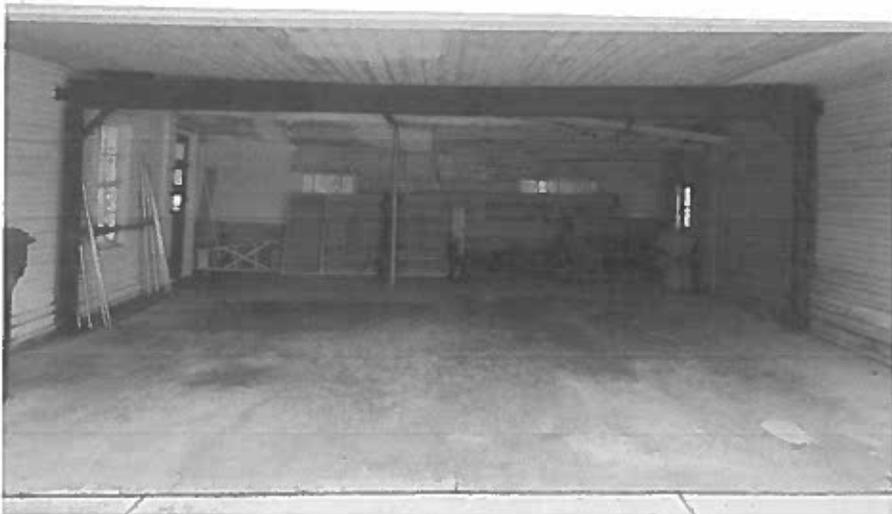
Interior of Coats Barn showing steel brace holding up building.

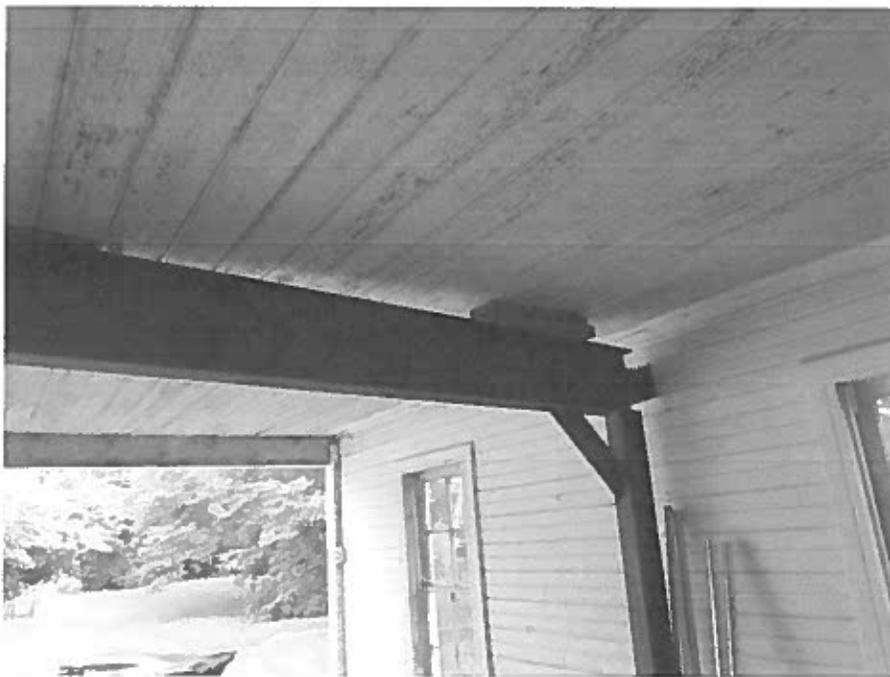
Wood shims used to help support building
